Glenn Ave & Pine Street

Speed Control Measures

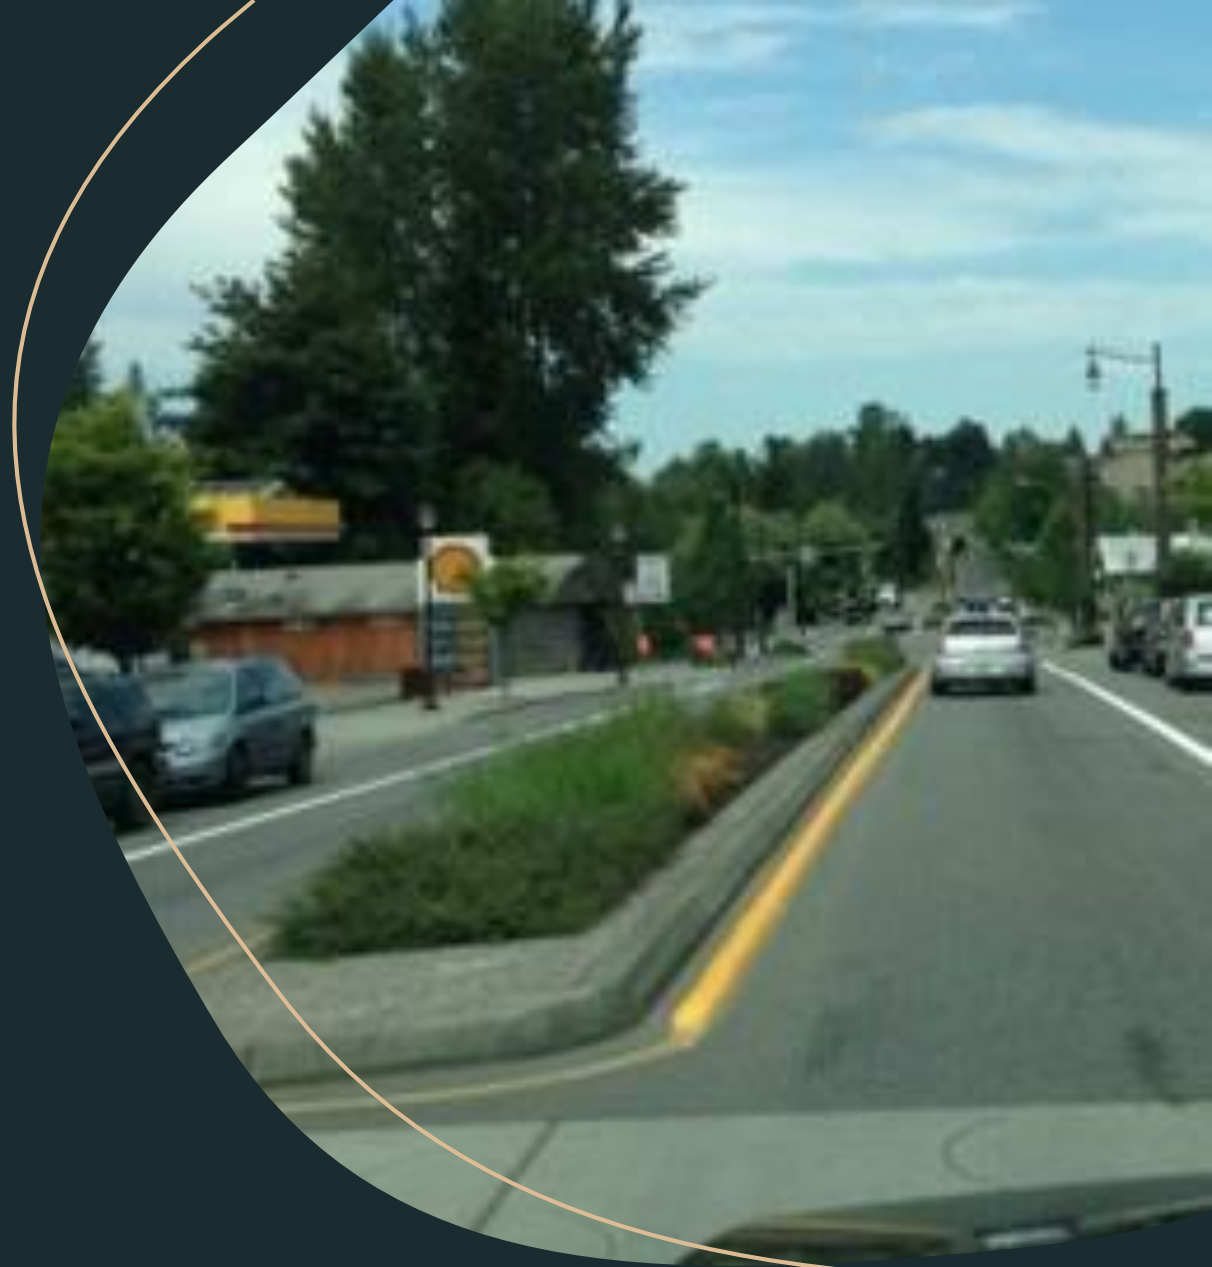
Design – Glenn/Pine Street

Plan and Benefit

- Install a narrow median on Pine.
 - Eliminates Corner Cutting
 - Slows Travel Onto Pine
- Add Stop Sign
 - Slows Travel Onto Glenn
 - Minimal Impact on Through Traffic

Pine Street Improvement

- Approximately **\$8,000** Based on Engineer's Estimate.
- Work Could Be Done by Public Works to Reduce Cost.

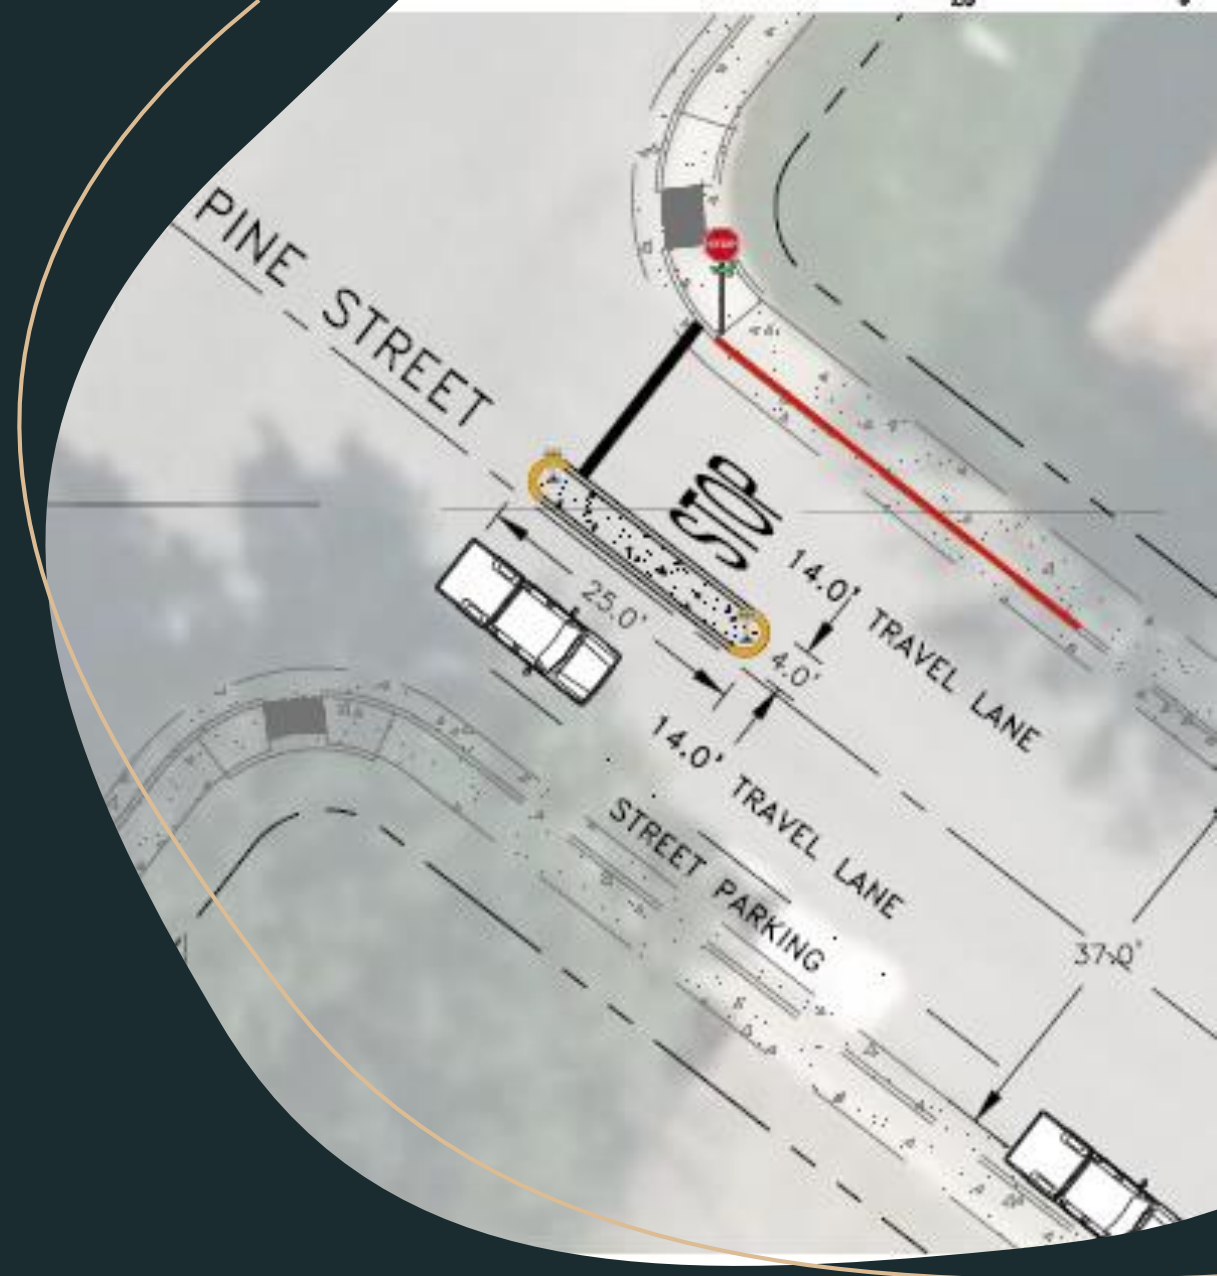
Potential Issues

- Noise Issues From Stop/Go Traffic

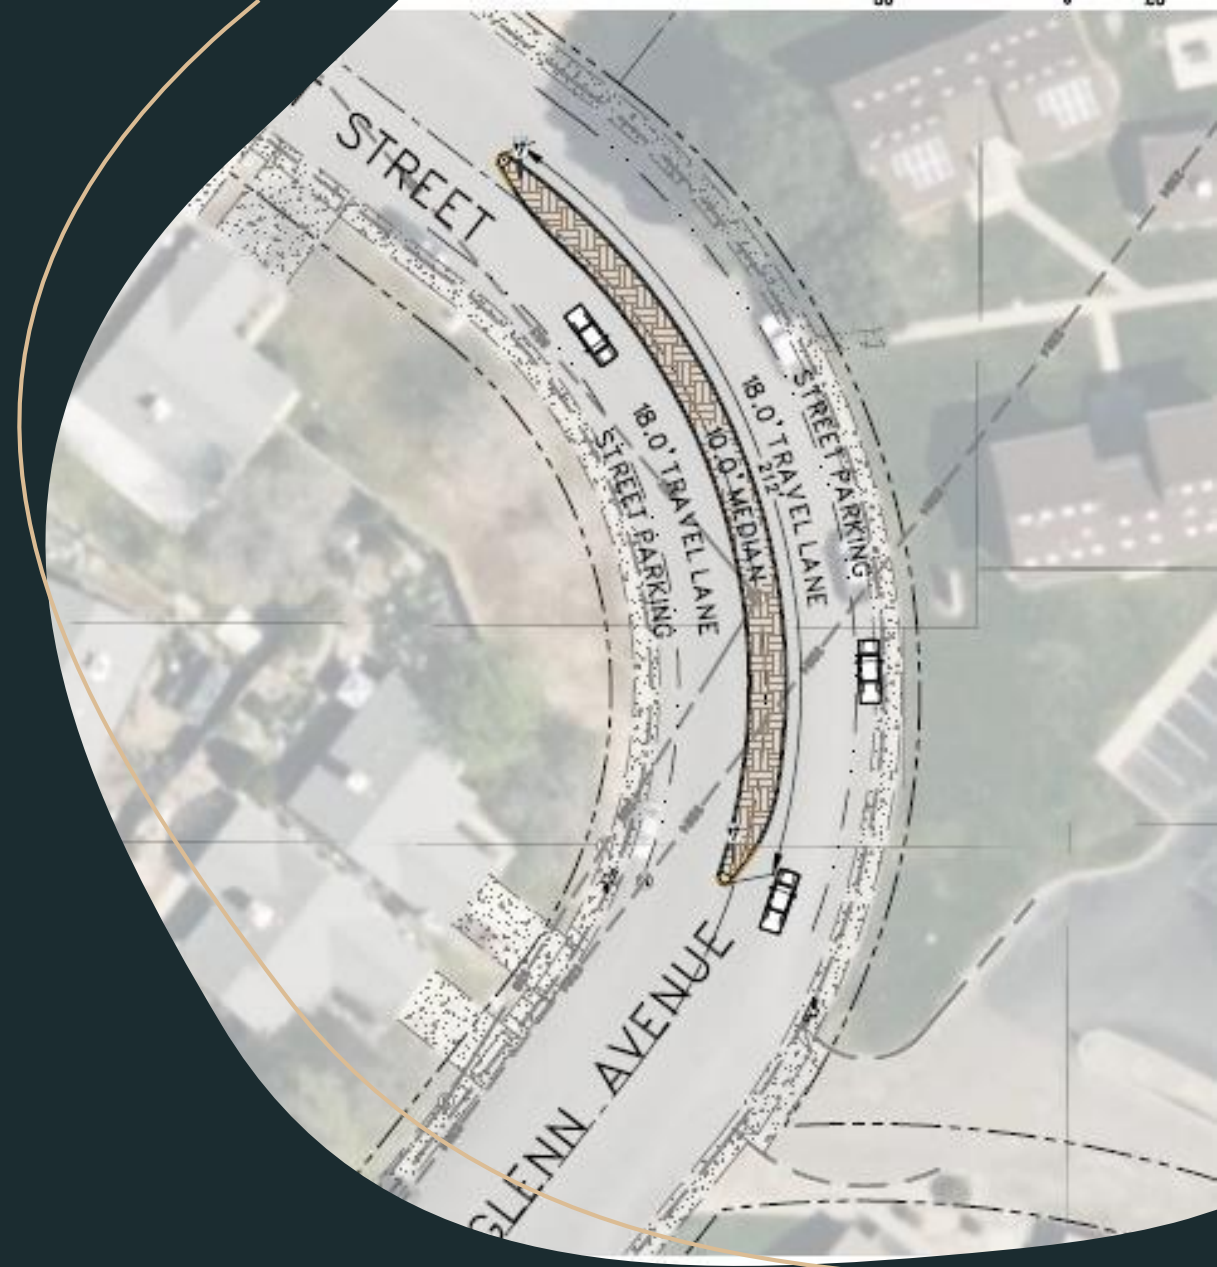
Design Glenn Avenue

Plan and Benefit

- Install 10' Median on Curve
 - Slows Traffic on 1st Glenn Prior to Apartment Entry.
 - No Impact to Residential Parking/Driveway Access

Potential Issues

- Relatively Expensive

Glenn Street Improvement

- Approximately **\$40,000** Based on Engineer's Estimate.
- Project Would Likely be Too Large for Public Works to Complete Efficiently.
